UNESCO ASIA-PACIFIC HERITAGE AWARDS
for Culture Heritage Conservation
2003 ENTRY FORM

Conservation of the Catholic Cathedral of the Immaculate Conception, HKSAR

16 Caine Road, Mid-Levels, Hong Kong Special Administrative Region, China

Date of Completion of the Project (must be post-October 1991) 8 December 2002

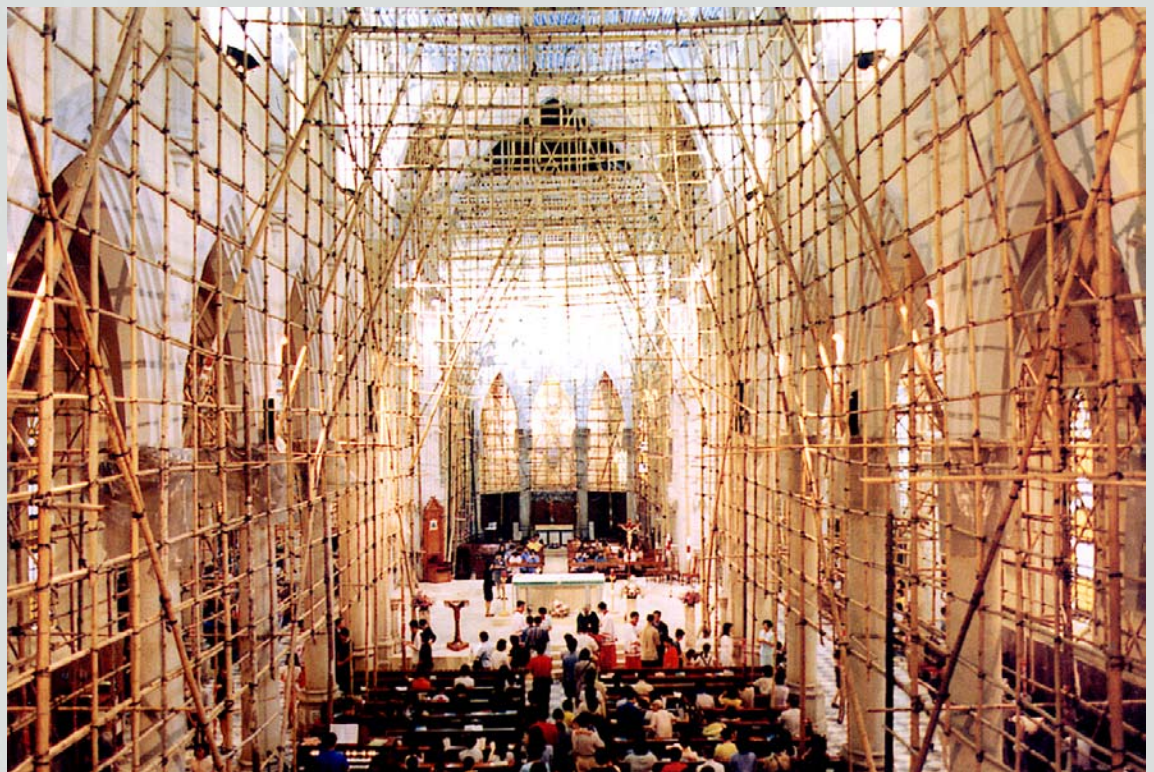
Interior view of scaffolding erection during conservation works.

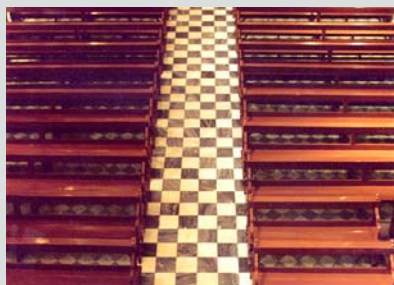
Different paving between walkway (black and white marble tile) and seating area (green ceramic tile)

During the repair of the internal marble flooring, salvaged floor tiles were used to match the existing flooring pattern. Where salvage tiles were insufficient to cover the floor paving at the St. Joseph altar, new marble tiles of matching colour to the oldest surviving flooring were laid to harmonize with the floor pattern.
